CROSS RIVER DAM
WESTCHESTER COUNTY
NEW YORK

INVENTORY NO 38

PHASE I INSPECTION REPORT
NATIONAL DAM SAFETY PROGRAM

NEW YORK DISTRICT CORPS OF ENGINEERS
AUGUST 1978

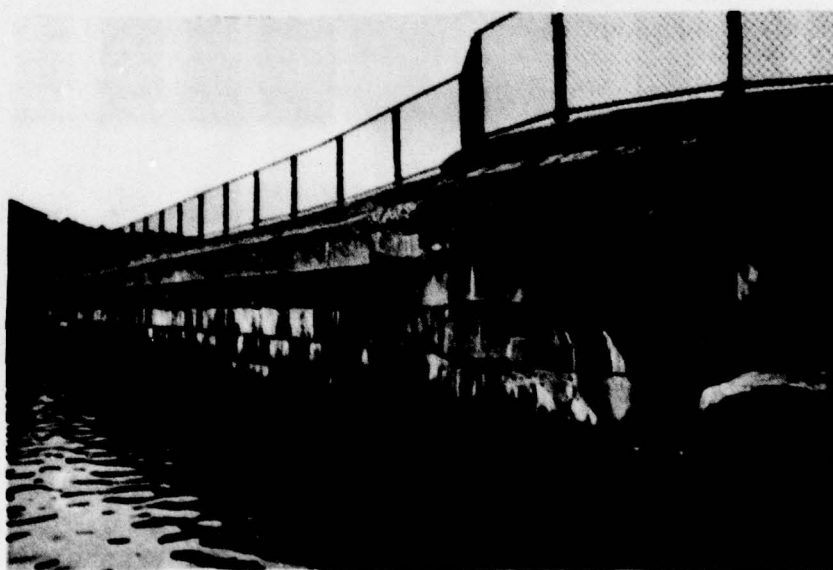
6. View across front of dam from spillway weir location. Circular portion of structure contains bastion room within dam. Floor of room is 0.66 feet above spillway. Room previously used to store flashboards which are no longer in use. Notice cracks in bastion area.

Photographs 6 through 11 show extensive damage to the bastion chambers. It is not known what caused this movement and cracking to occur. Possible causes for this damage are frost heave, thermal expansion, creep, pore pressure, foundation movement, reservoir head, vehicular traffic loads and seismic activity. The fracture and displacements seem to indicate expansion along the longitudinal axis of the dam. The bastion area being a circular (relatively) thin walled structure is the weakest point in the dams longitudinal axis and is between the south abutment and the north ends bridge arch. Expansion forces seem to have pushed the front wall of the bastion area out. Fractured column joints show movement to the North. Lateral torsion failures were visible in the roads floor beams. The cause of these fractures is not known, however, the most prevalent explanation appears to be frost heave.

of the bastion should be done as soon as possible, and the area should continue to be kept under close observation. The owner should determine the cause of the extensive structural damage in the bastion chamber.

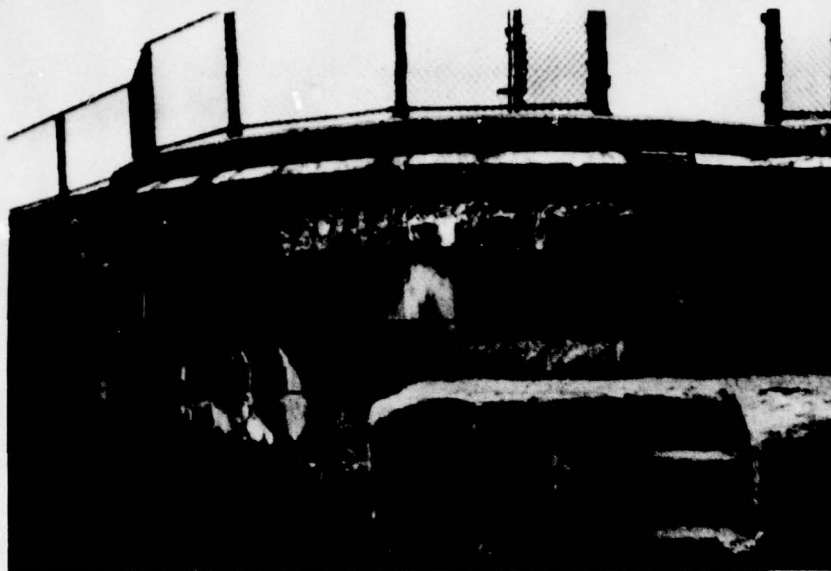
7. View of bastion area. Notice severe cracks.

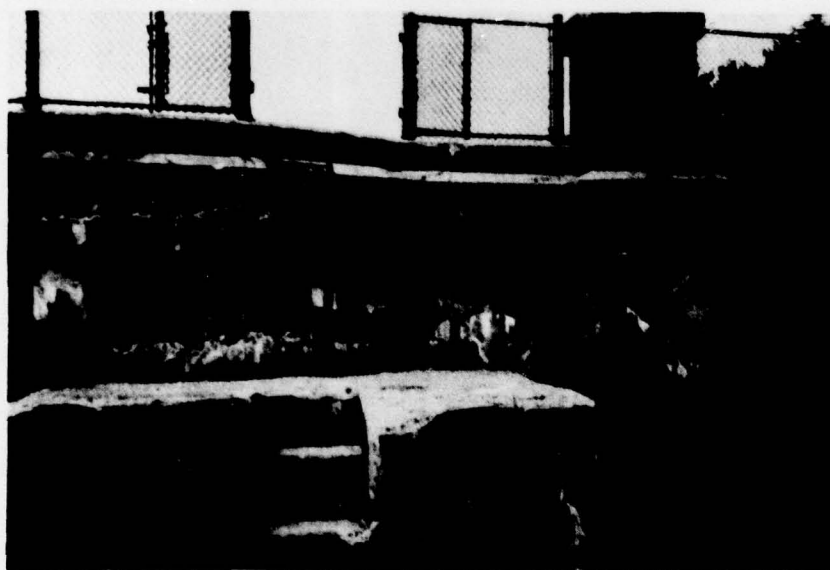
8. Closeup of bastion's right side showing extensive fracture of non-reinforced concrete wall sections.

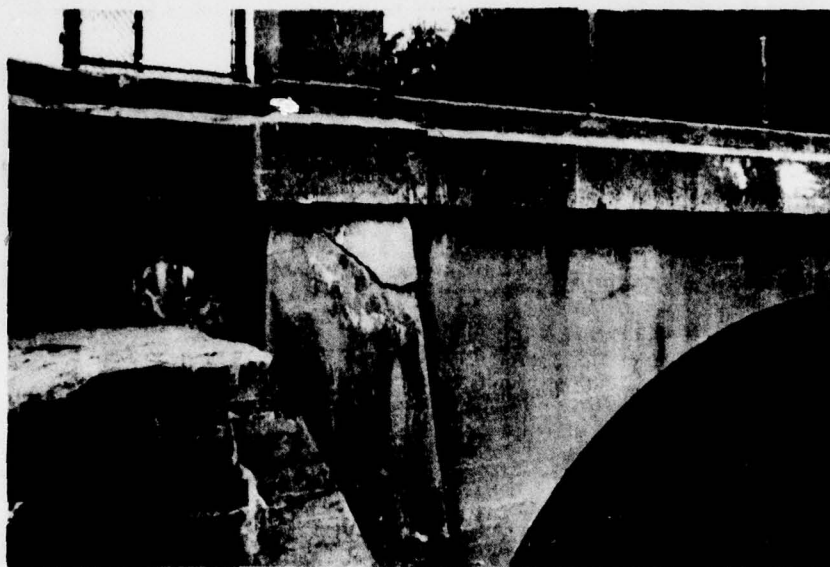
9. Detail of bridge abutment wall showing in right portion of picture No. 8.

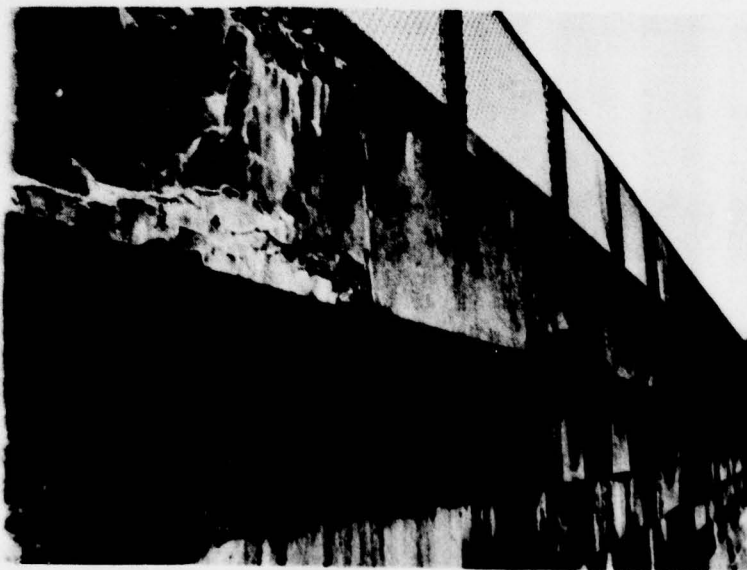
14. Detail of spalling of concrete facing on south side of downstream face of dam.

The concrete facing of the dam has deteriorated as can be seen in Photographs 14, 23, 24, 25, 26, 27 and 28. In Photographs 23 and 24 the surface of the dam was noted to be moist. This condition could be caused by absorbed moisture from rainfall or seepage. Photographs 25 and 26 show where spalling has occurred up to eight inches in depth (estimated), forming a surface crack up to the top of the dam. Another crack line occurs on the south side of the
